Manhole Inspection Summary

Manhole # S19A__009MH

Location Address: **740 LANVALE ST**

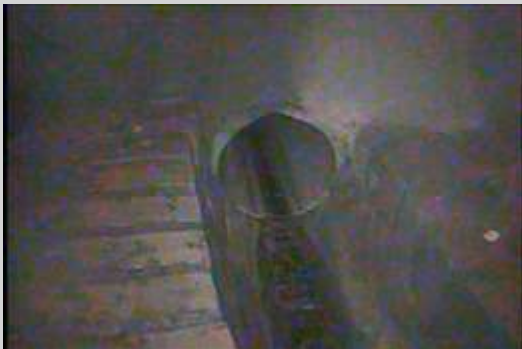
8 O'Clock Inflow

8 in. Circular Gravity Sewer
Pipe In @ 8 O'Clock

Pipe Height: **8.4** (in.) Rod and Bar (Angled)
Pipe Material: **Clay** ☐ Pipe Lined
Invert Depth: **11.54** (ft.) Flow Characteristics: **Slow**
Deposits: ☒ **None** ☐ Mud ☐ Sludge ☐ Debris ☐ Grease
Silt Depth: (in.) Deposits Extent:
Infiltration: **None** Pipe Seal Cond: **Sound**
